# Detecting an improperly-lubricated journal bearing in a centrifugal compressor (when your 'toolbox' isn't full)

by Karl Enge, P.E.

### High vibration on plant air compressor

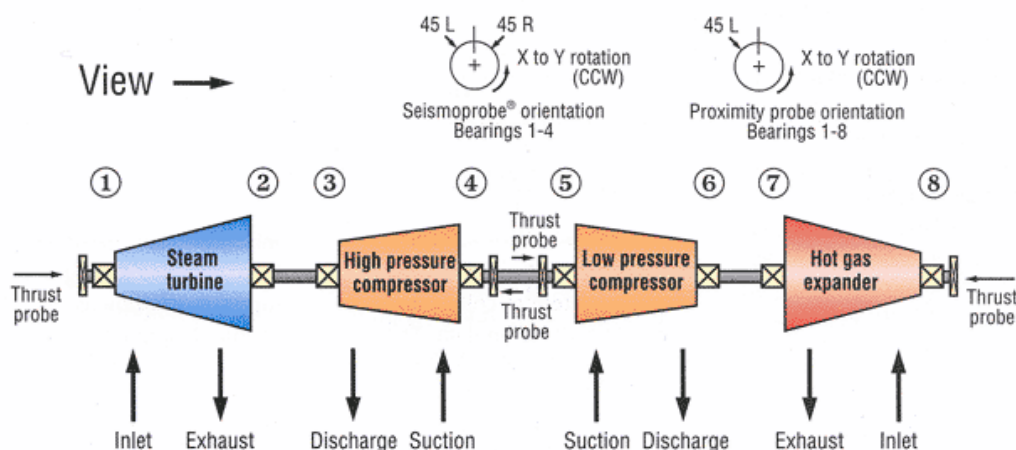
Figure 1  
Machinery arrangement diagram.

per minute of air. It is rated at 6100 horsepower and includes a steam turbine driver, a high pressure (HP) and low pressure (LP) centrifugal air compressor, and a hot gas expander (Figure 1). The train operates at speeds near 10,600 rpm.

imity probes mounted at each radial and thrust bearing provided shaft vibration and position information (Figure 1). No Keyphasor® probe was installed to provide a 1X rotor phase reference. The signal from a proximity probe viewing a 60-tooth auxiliary drive gear (providing a 60X pulse) was directed to a tachometer in the control room.
